# MICROCHIP PIC16F631/677/685/687/689/690

## PIC16F631/677/685/687/689/690 Rev. A Silicon/Data Sheet Errata

The PIC16F631/677/685/687/689/690 parts you have received conform functionally to the Device Data Sheet (DS41262C), except for the anomalies described below.

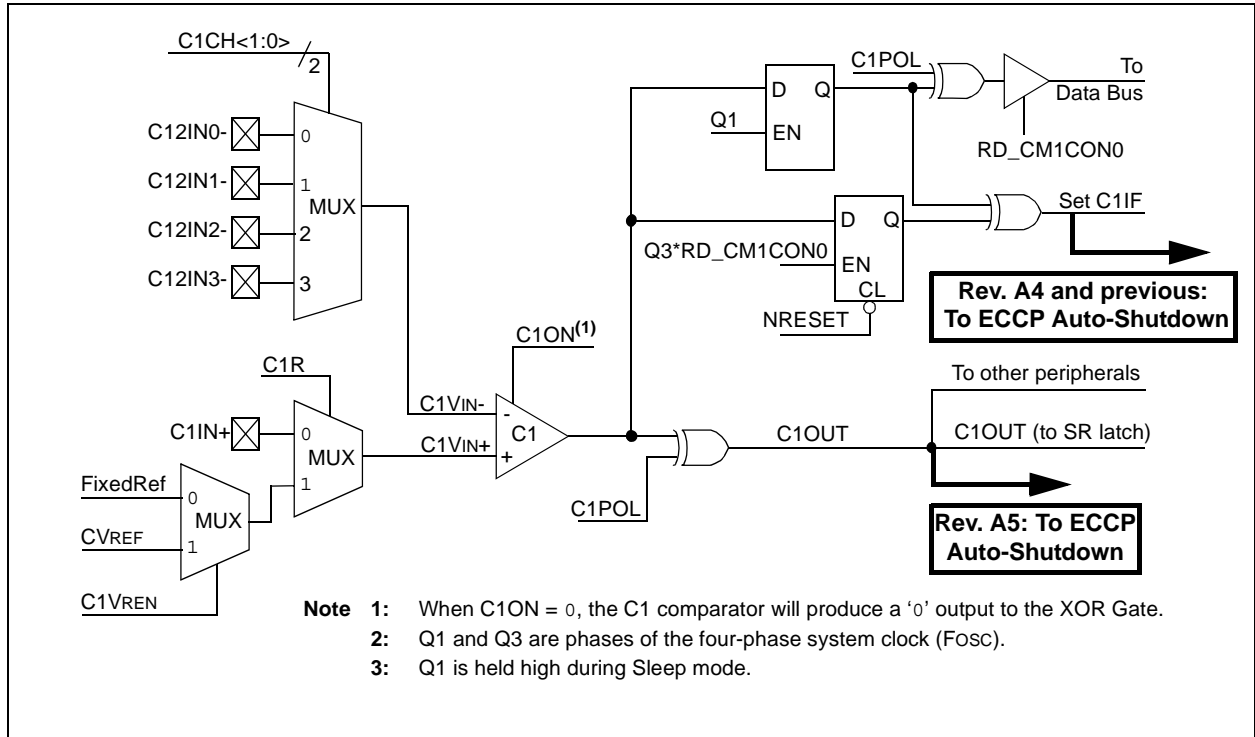
**FIGURE 8-2: COMPARATOR C1 SIMPLIFIED BLOCK DIAGRAM**

The PIC16F631/677/685/687/689/690 Rev. A4 silicon for the ECCP Auto-Shutdown is connected to the C1IF and C2IF flags. See Figures 8-2 and 8-3 on the following page.

The auto-shutdown connection (Rev. A4 and previous) to C1IF and C2IF causes the auto-shutdown to incorrectly operate synchronously. Additionally, reads of CMxCON0 will incorrectly clear an auto-shutdown event.

- 1) Poll the CxOUT bit until it is low.
- 2) Read CMxCON0 to precondition CxIF.
- 3) If CMxCON0 is read while CxOUT is changing, repeat steps 1 and 2.

The Silicon Rev. A5 (now shipping) and later revision devices have moved the auto-shutdown connection from CxIF to CxOUT. This will eliminate the synchronous shutdown and simplify the use of the comparator for a shutdown event. Figure 1 shows the function of auto-shutdown before and after the device revision.
