Date	Ref. No.	Model	
22.01.09	09HV002	RDR-GX120, RDR-GX220, RDR-GX330, RDR-GXD360, RDR-HX520, RDR-HX525, RDR-HX720, RDR-HX722, RDR-HX725, RDR-HX727, RDR-HX730, RDR-HX920, RDR-HX925, RDR-HXD560, RDR-HXD760	HV
Subject			IRIS
Set Freezes after "WELCOME" Message on FL Display			1110

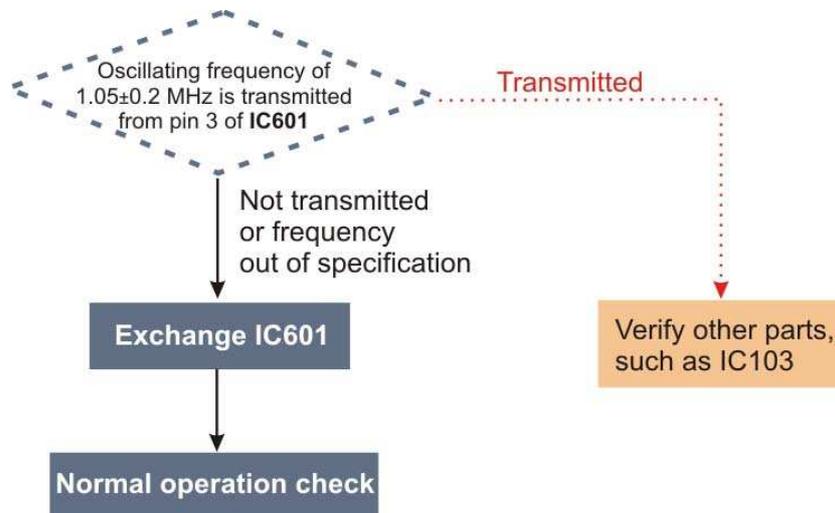
The set may freeze after "WELCOME" appears on the FL display, and may refuse to power on.

Voltage output of the DC-DC converter IC is not correctly stabilized.

- The output of the DC-DC converter is a square pulse. Please measure at pin 3 of the IC, using an oscilloscope. Check that the signal is within the [WAVEFORM] specifications. Proceed according to the flowchart below.

- Refer to the table below when exchanging IC601.
